**SPECIAL INVESTIGATION  
PASSIVE BELT SYSTEM  
DSI-90-AB-05**

CASE NUMBER: DSI-90-AB-05

Vehicle 1 is a 1990 Buick LeSabre four-door Sedan, equipped with passive 3 point lap shoulder belts, and was being driven by a 71 year old male. The right front passenger was a 68 year old female. They were traveling the back roads for a leisurely drive and had entered the asphalt road from a two-lane gravel road to the west. Vehicle 1 was traveling easterly in the eastbound lane. Vehicle 2 is a 1980 Chevrolet Monte Carlo and was driven by a 19 year old male who was reportedly drinking beer while driving. The vehicle was allegedly traveling at a high rate of speed westbound on a two-lane rural asphalt road.

**DYNAMIC SCIENCE, INC.**  
**HEAVY TRUCK ACCIDENT INVESTIGATION**  
**CASE NUMBER: DSI-90-AB-05**

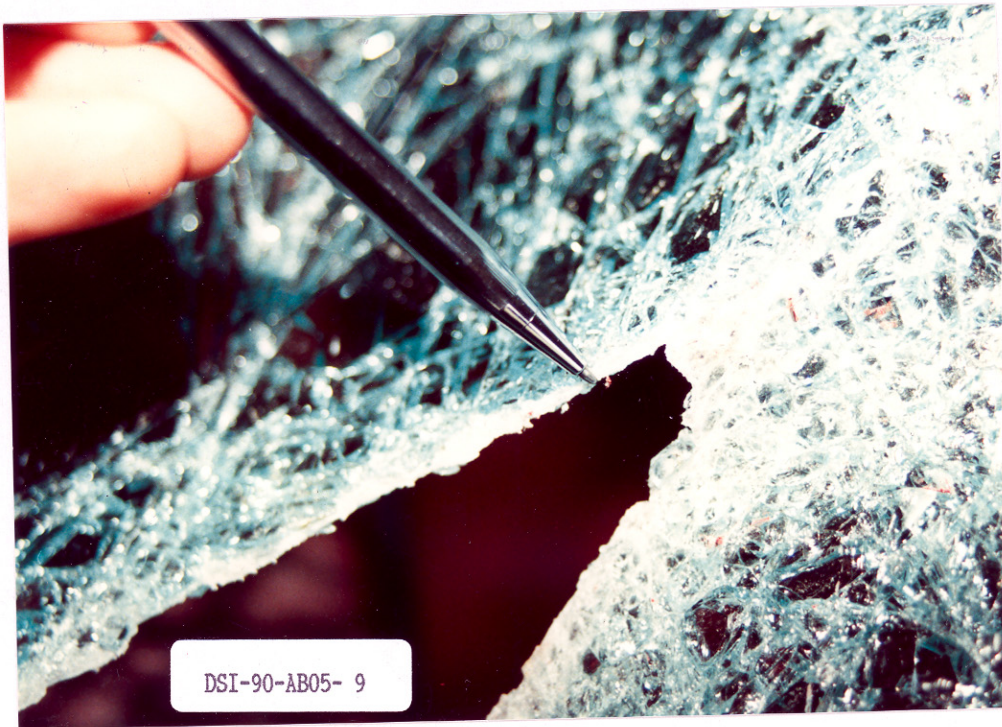
DSI-90-AB05-11

PHOTO	VEHICLE NO.	ORIENTATION	SUBJECT
1-2	1	SOUTH	PATH OF V1
3	2	WEST	PATH OF V2
5-33	1	CCW	EXTERIOR
	1		PHOTOS 6-11, DETAIL HOOD DAMAGE TO
			WINDSHIELD
	1		PHOTOS 12-14, SKIN, DRIVER CONTACT
			WITH WINDSHIELD
	1		PHOTO 16, DETAIL, TOP DAMAGE FROM
			CONTACT WITH AIRBORNE V2
	1		PHOTO 17, DETAIL, LEFT FRONT DOOR
			FRAME DAMAGE FROM CONTACT WITH
			AIRBORNE V2
	1		PHOTOS 18-19, DETAIL, TOP DAMAGE
			FROM CONTACT WITH AIRBORNE V2
	1		PHOTO 20, DETAIL, LEFT FRONT DOOR
			FRAME DAMAGE FROM CONTACT WITH
			AIRBORNE V2
	1		PHOTO 21, DETAIL, TOP DAMAGE FROM
			CONTACT WITH AIRBORNE V2
34-62	2	CCW	EXTERIOR
	2		PHOTO 52, DETAIL, RIGHT A PILLAR
	2		PHOTOS 53-56, V2 DAMAGE, CONTACT WITH
			V1 WHILE V2 AIRBORNE AND V2 GROUND
			CONTACT DURING ROLLOVER
